case study

Beech House, Crawley

ABS Network Solutions Ltd

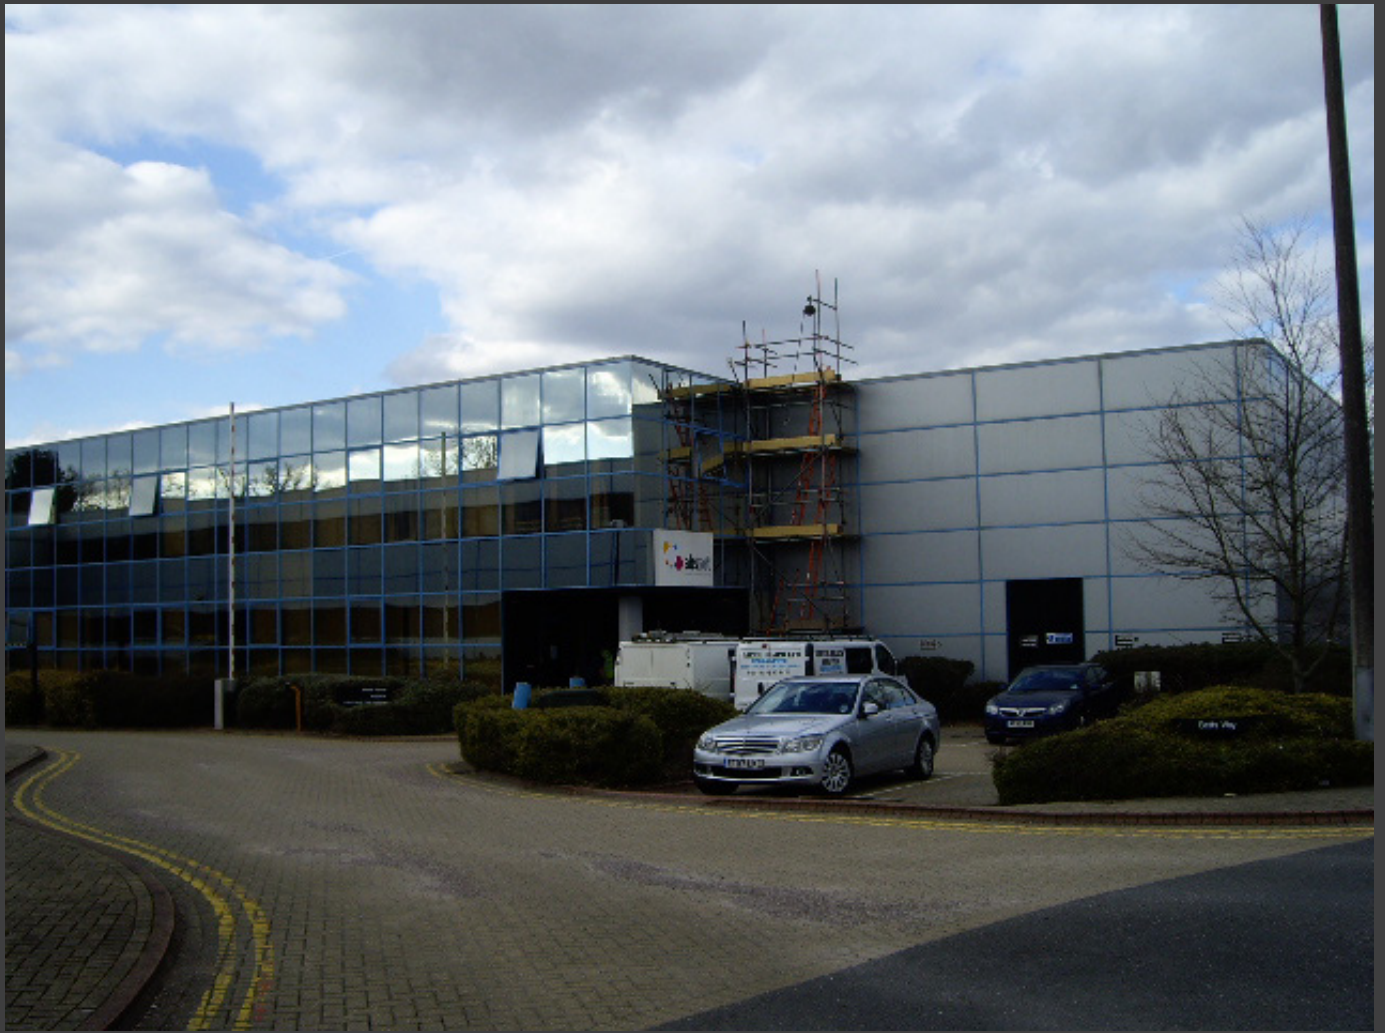
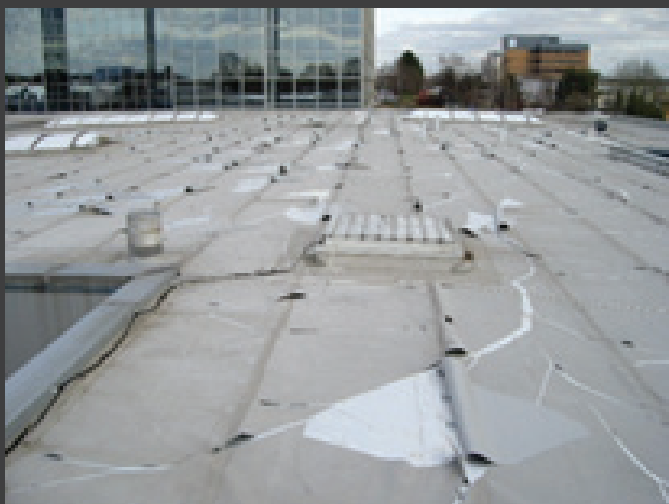
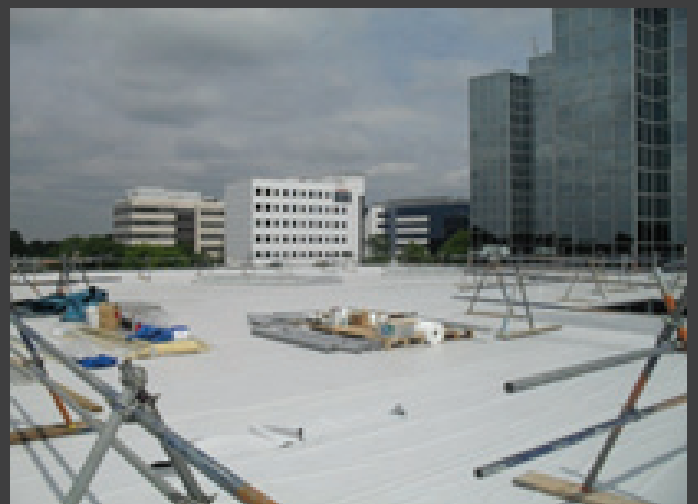
Set Square visited site a few hours later to find 75% of the roof covering had shredded, exposing the building to the elements. The Client was immediately put on notice as to the potential devastation should heavy rain occur with the recommendation that the business be moved immediately. Staff had packed and were in temporary accommodation by the end of the day. Essential services (IT and telephone) were protected to assist staff to work from home.

Investigations were undertaken with the assistance of a forensic laboratory to establish the cause of the sudden failure of the roof covering. Set Square concluded this had been caused by thermal shock on brittle and cold roof elements, causing fracture of the materials. This analysis was accepted by insurers and Set Square were instructed to organize the replacement of the complete roof covering at a cost of £72k.

Set Square's prompt response and business-focussed assisted the Client to develop Business Continuity Plans involving the immediate relocation of all staff off site, the protection of essential services from water ingress, and the provision of temporary covers at roof level to make the building watertight. Set Square's analysis of the cause of defect secured full recovery of cost of works from Insurers.
